Situation Photo Log

Thursday, September 20, 2012

Kalamazoo River / Enbridge Spill

Prepared by:
Matthew Haak
START-USEPA
Situation Unit Leader

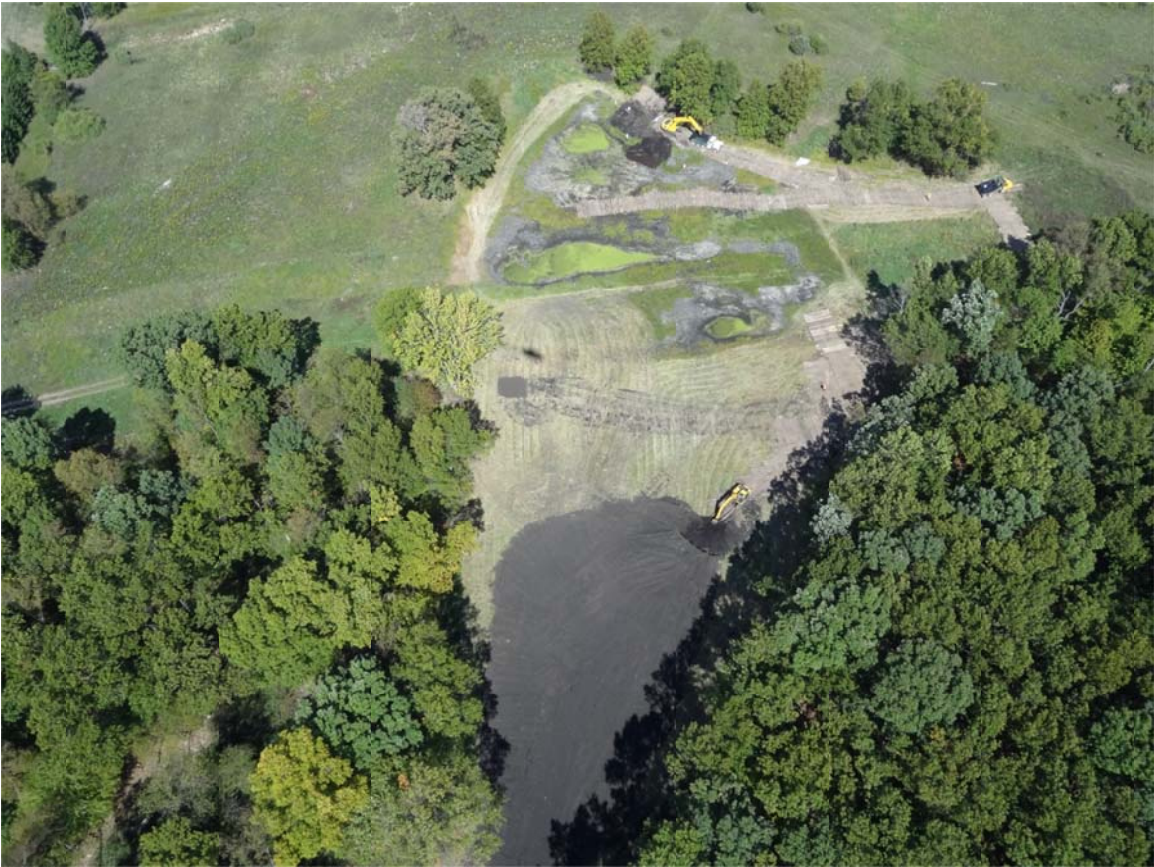
1. Source Area excavation work.

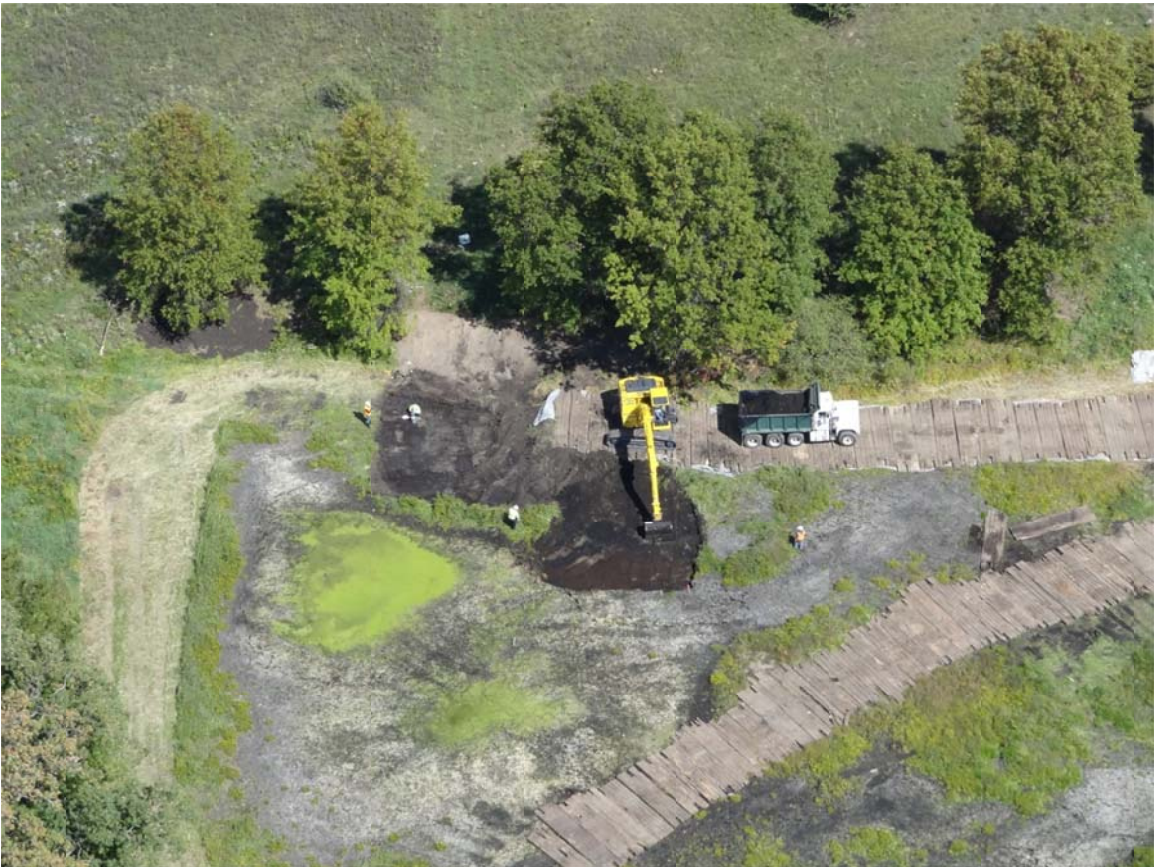
2. Source Area excavation work.

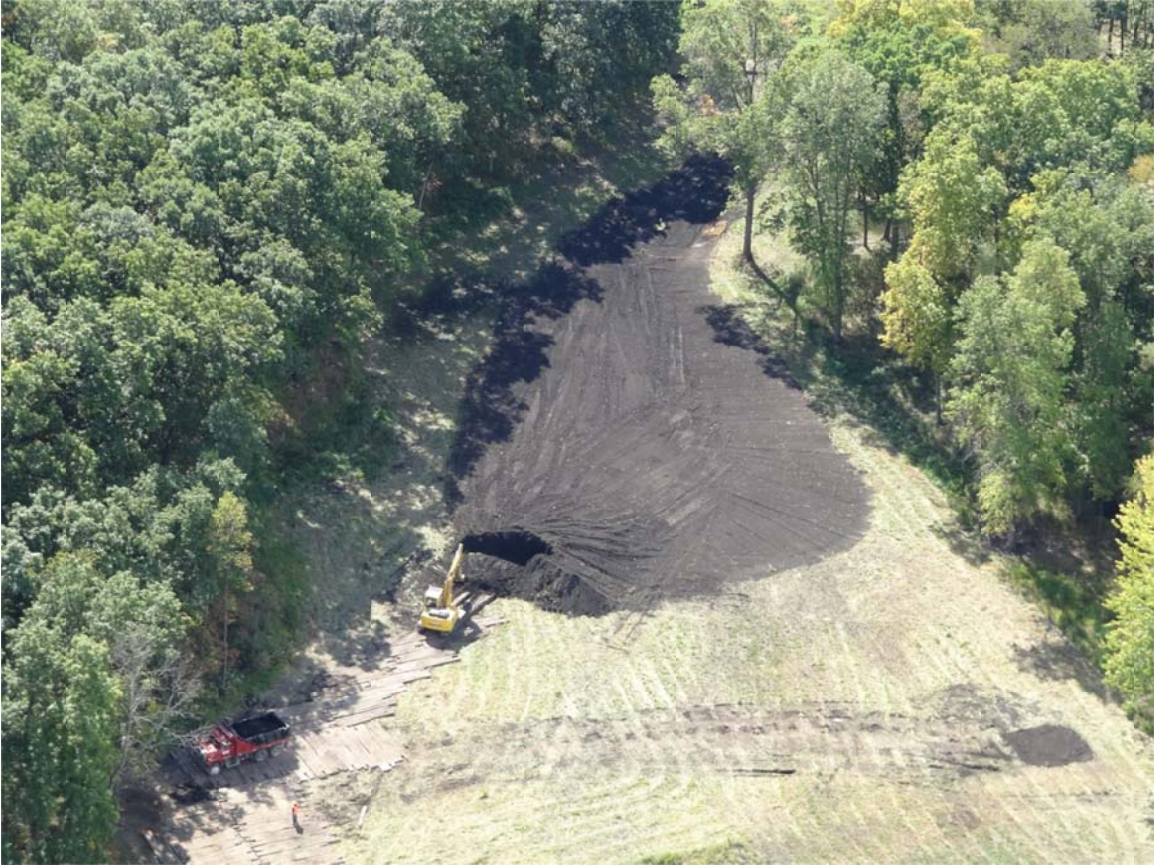
3. Source Area excavation work.

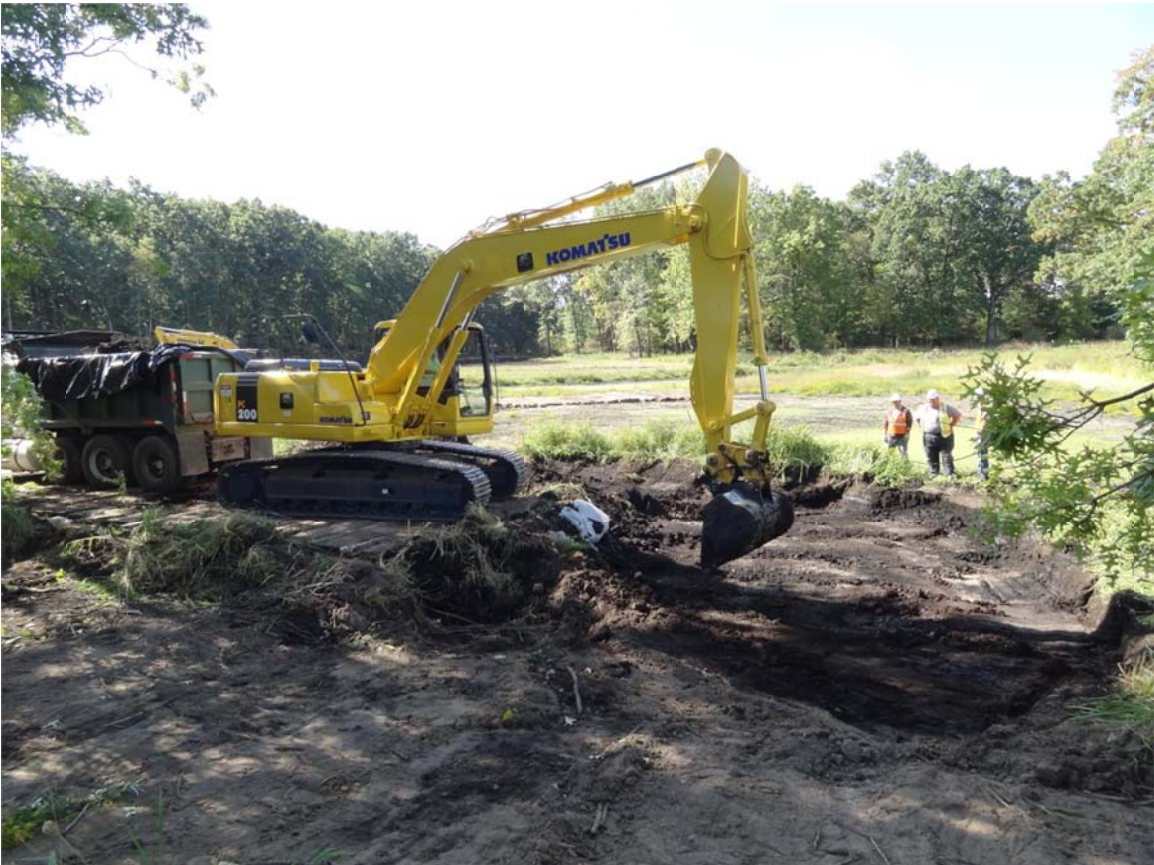
4. Source Area excavation work.

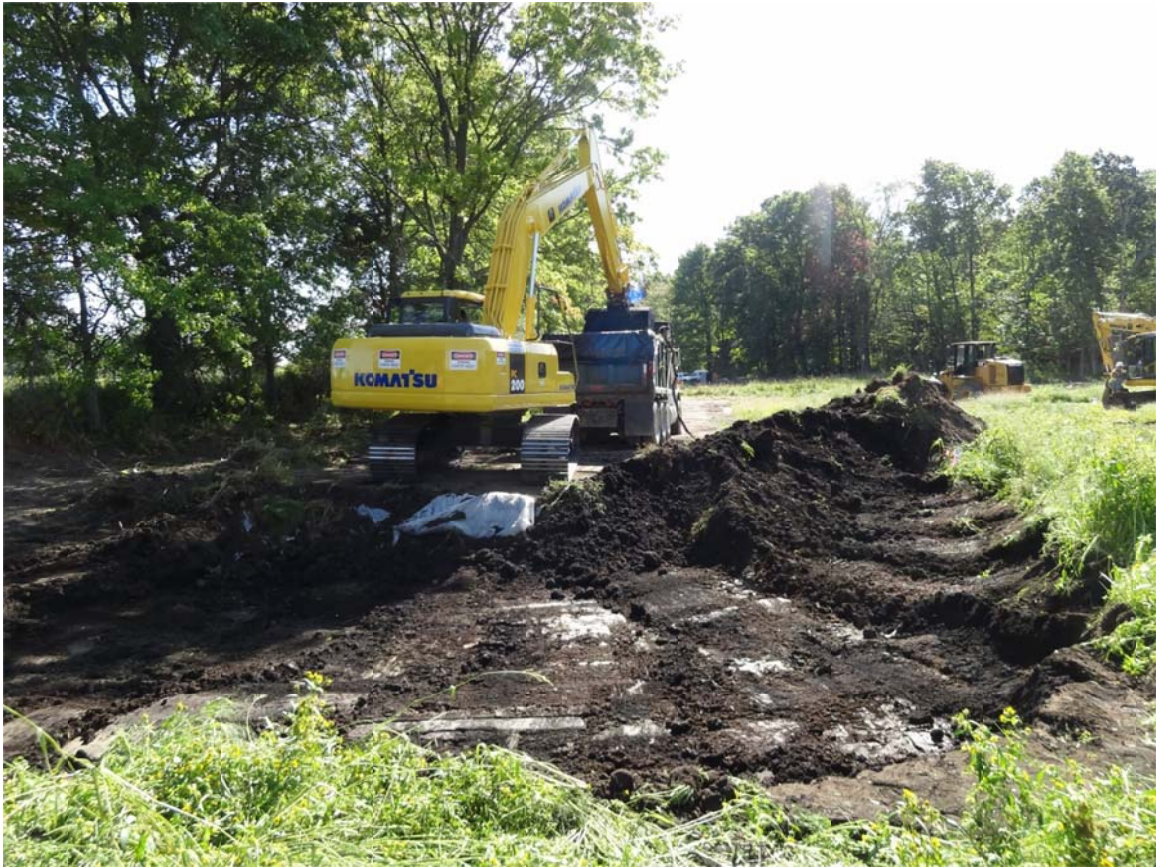
5. Source Area excavation work.

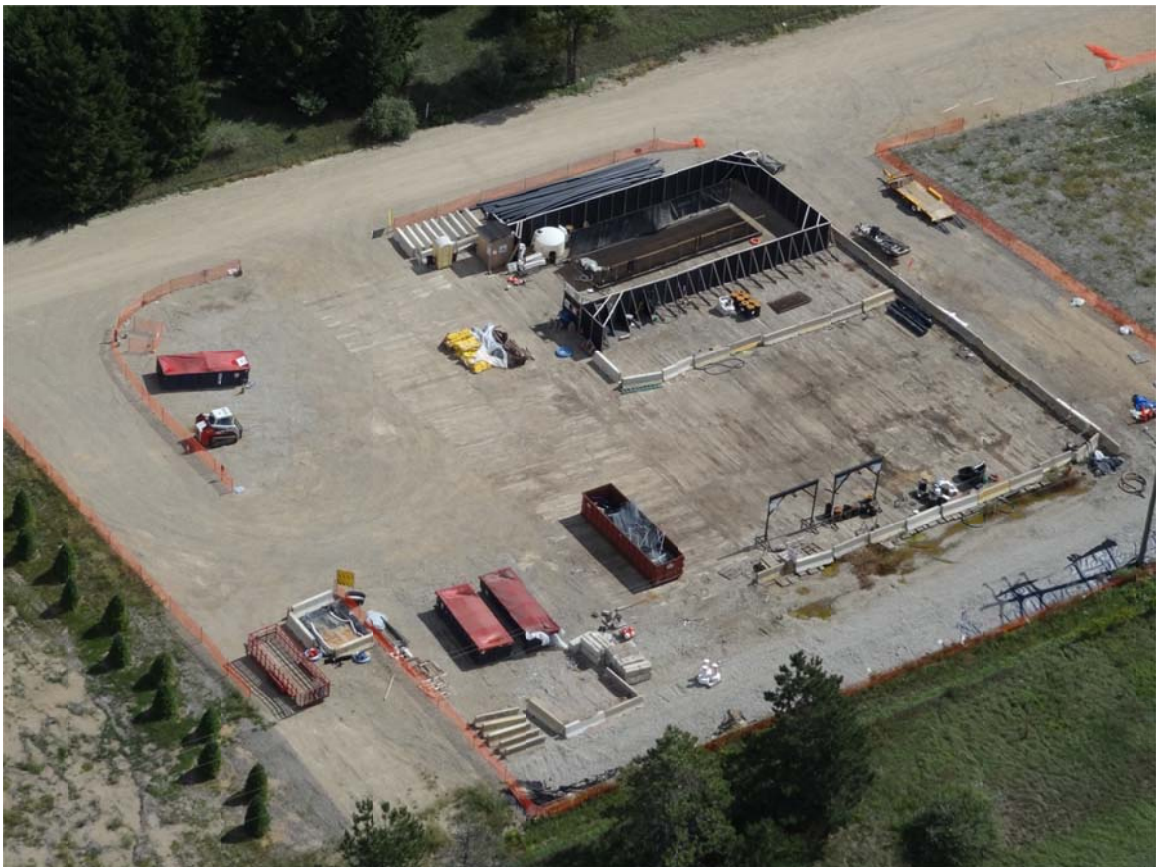
6. Frac-Tank City no activity observed.

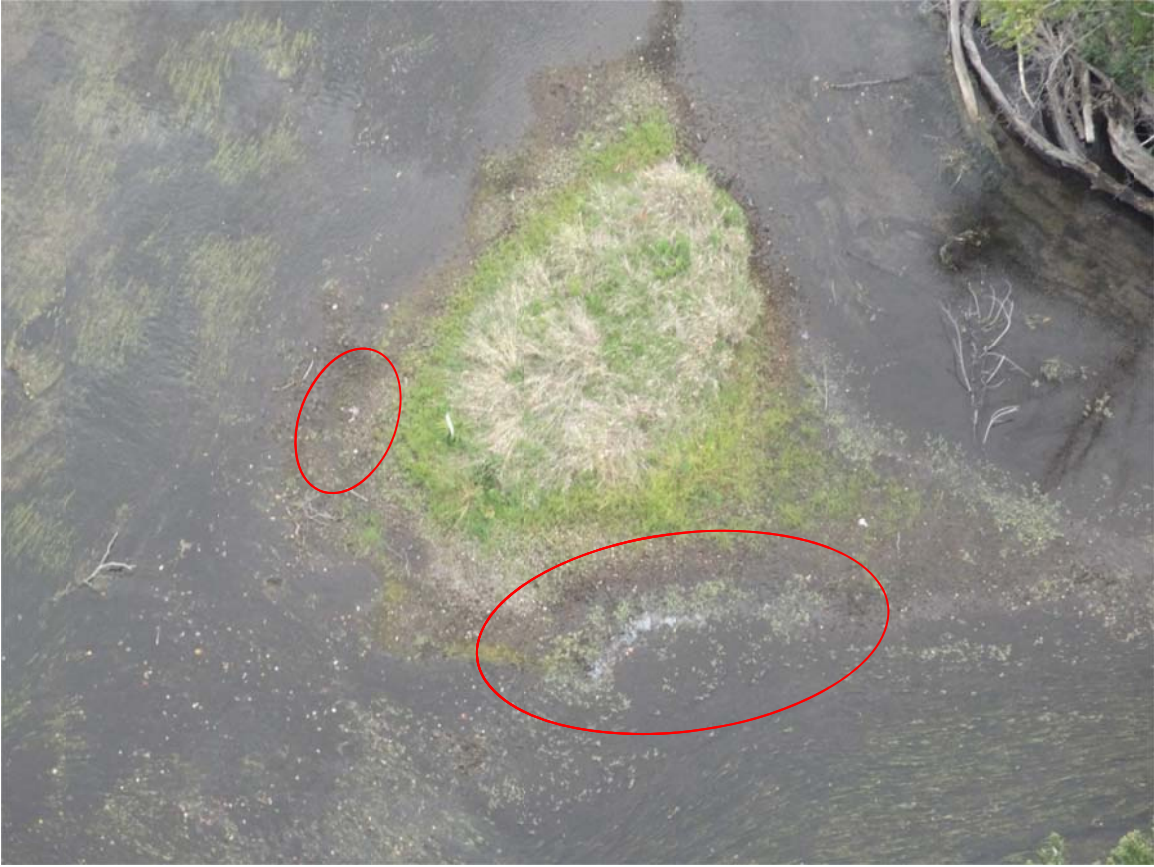
7. MP2.75 RDB Island sheen observed.

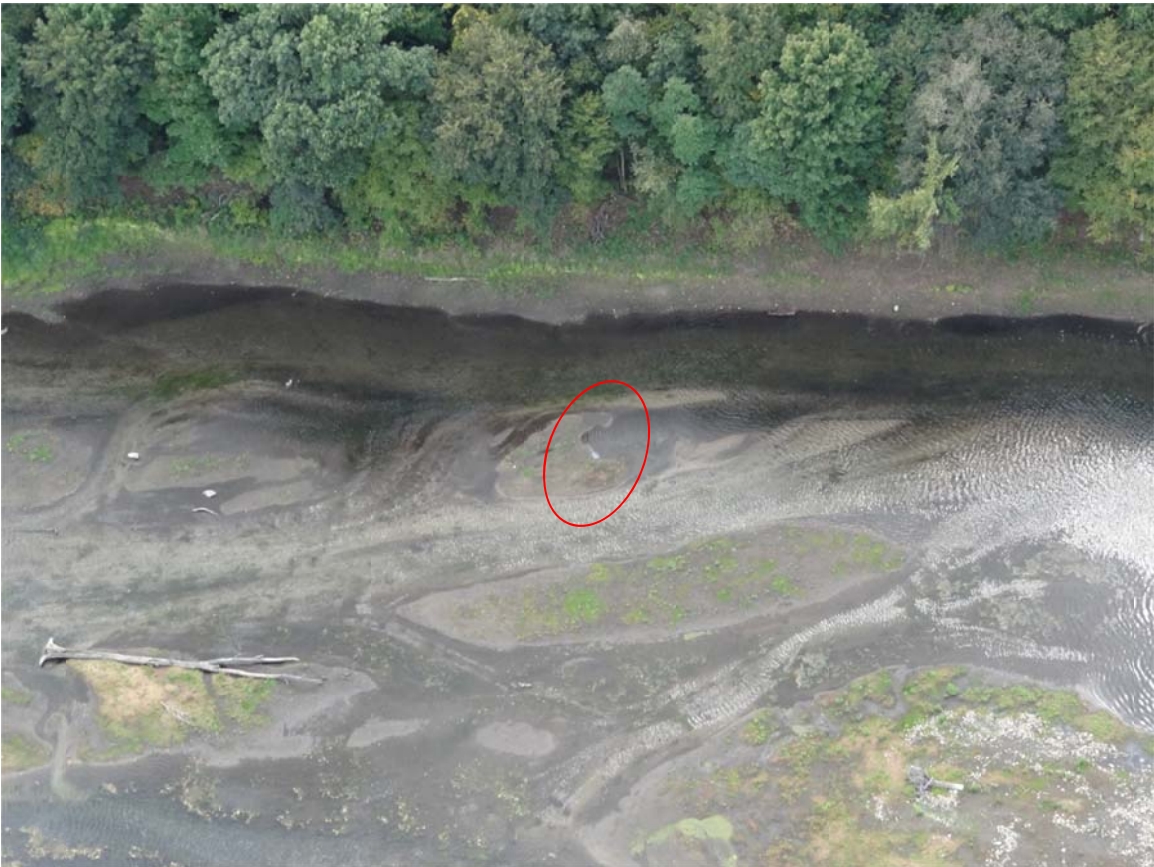
8. MP4.4 LDB observed sheen.

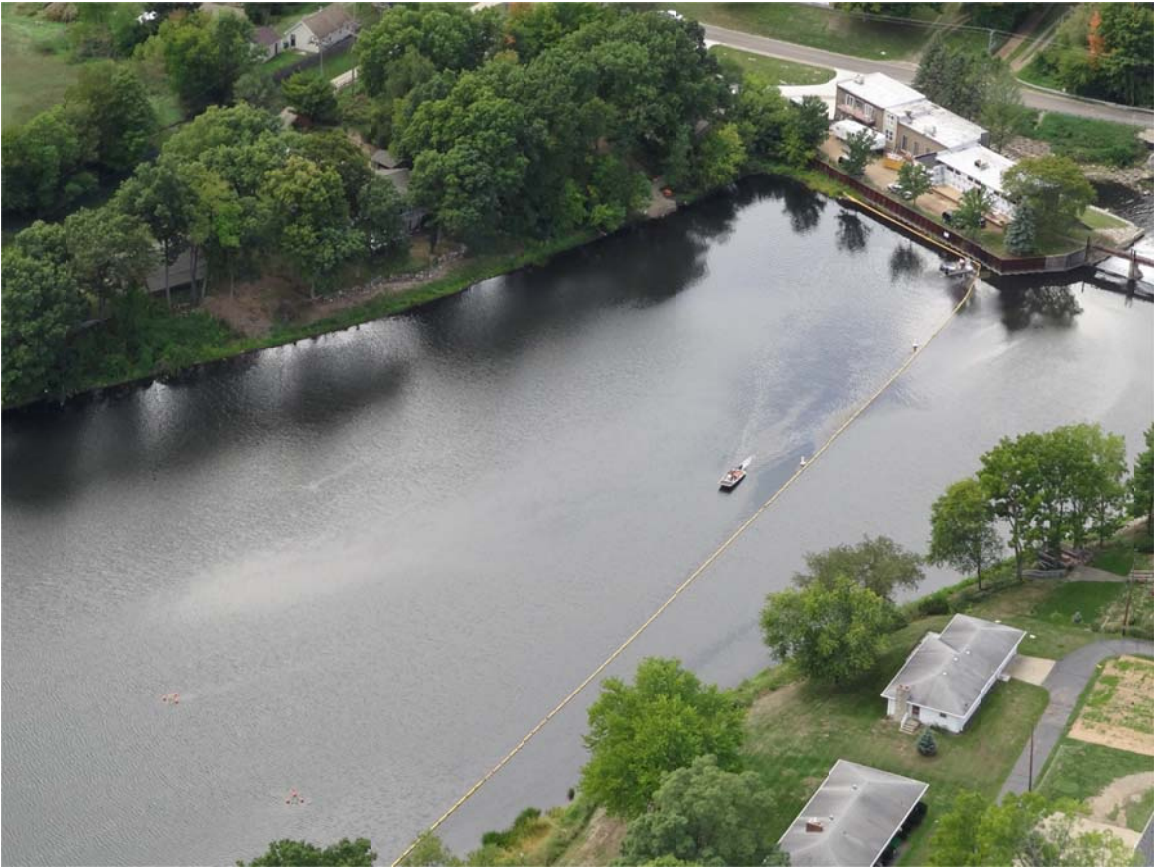
9. Ceresco Dam observed crews performing boom maintenance.

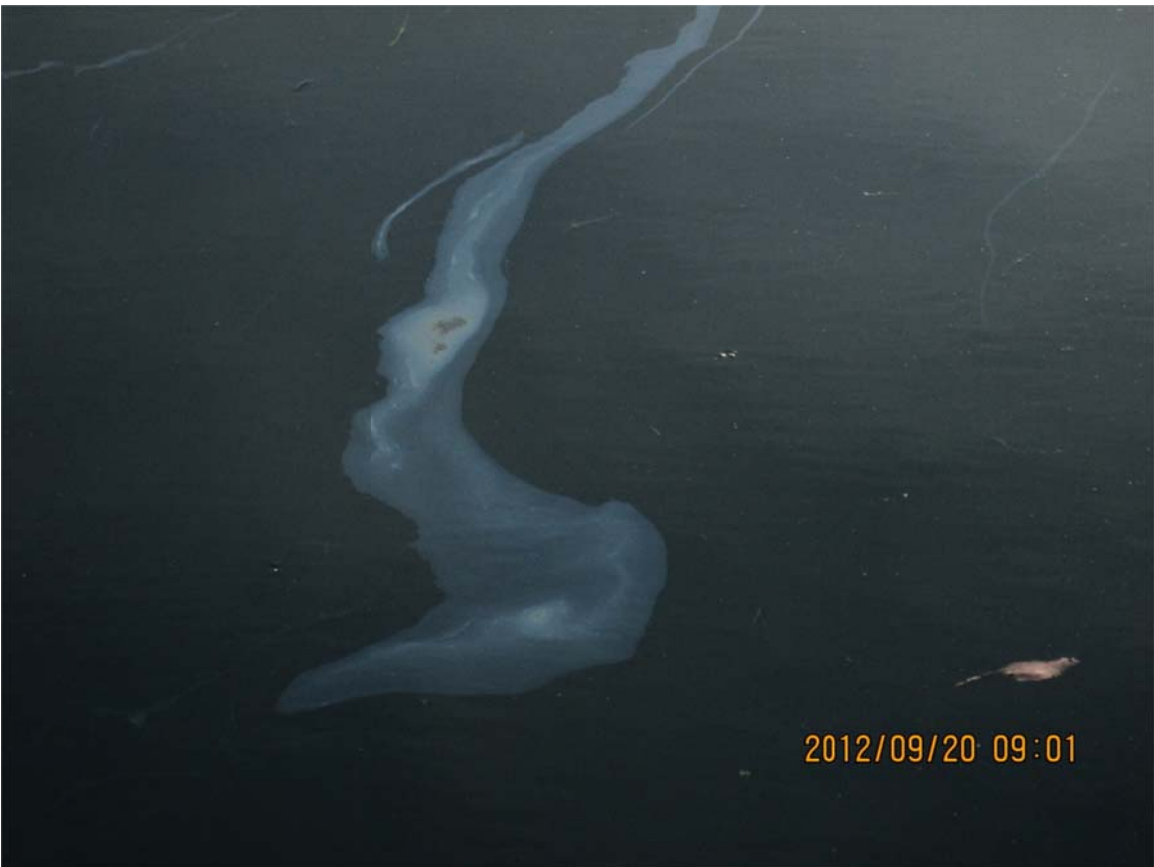
10. Ceresco Dam sheen observed.

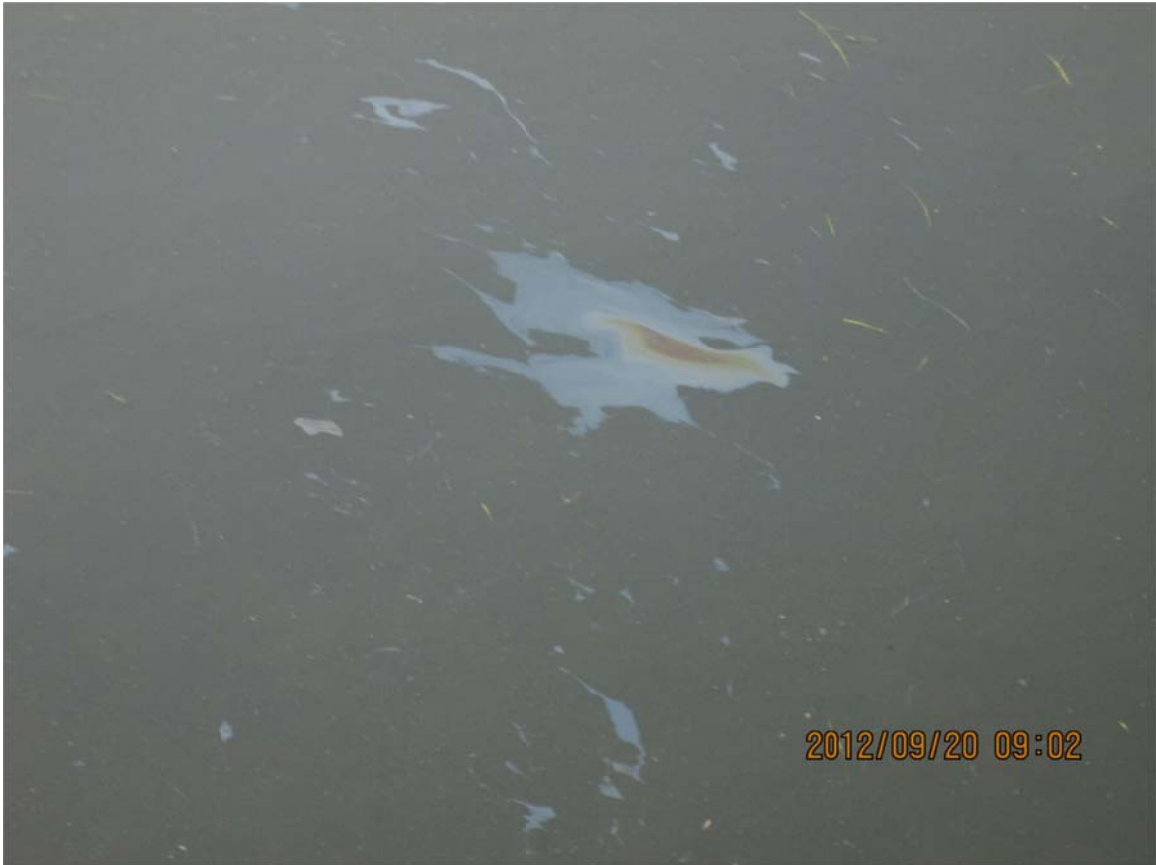
11. Ceresco Dam sheen observed.

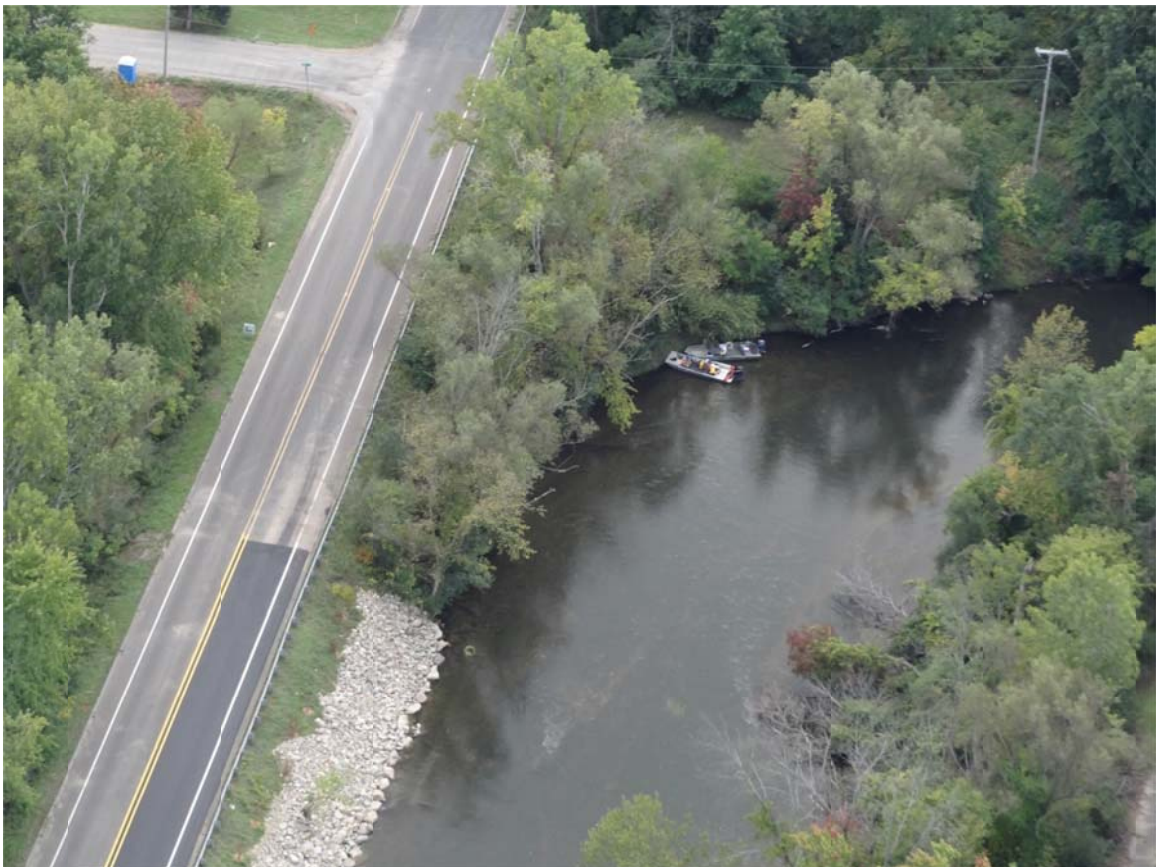
12. MP12.25 LDB observed a bathymetry crew.

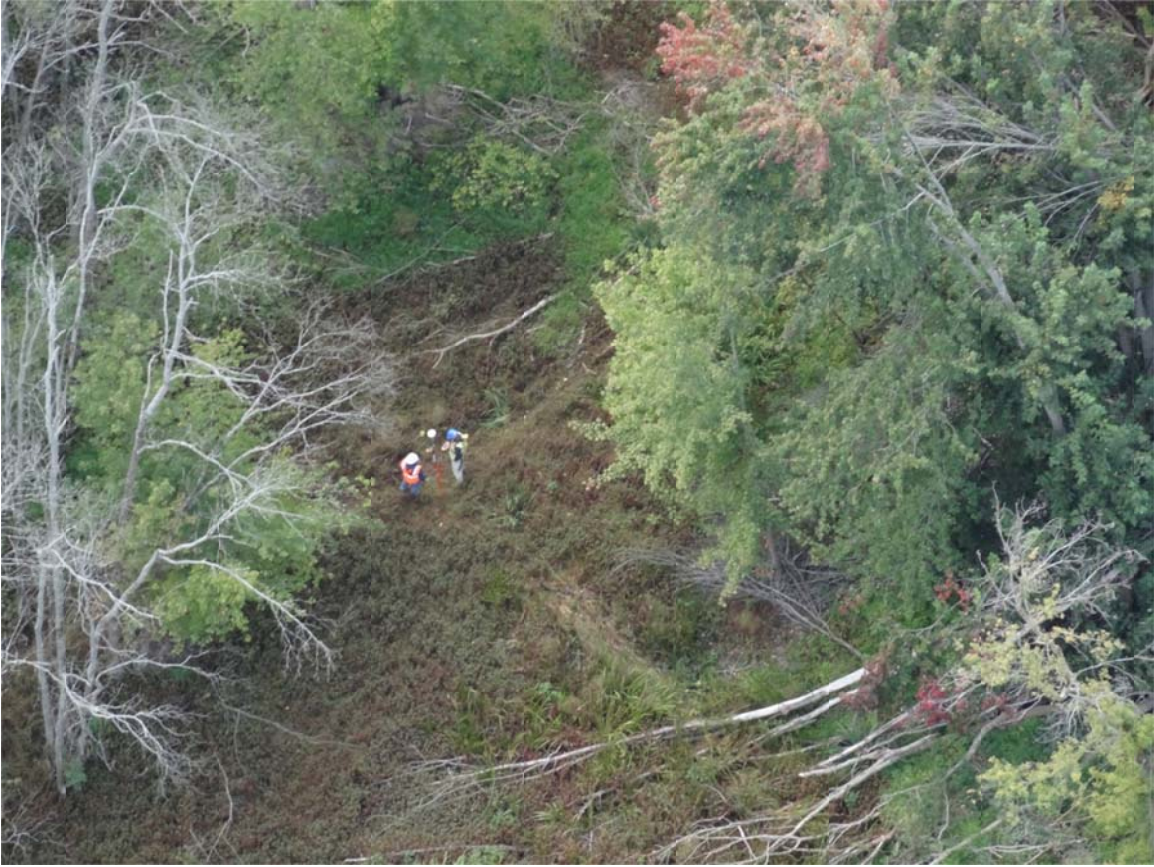
13. MP11.79 back channel observed a bathymetry crew.

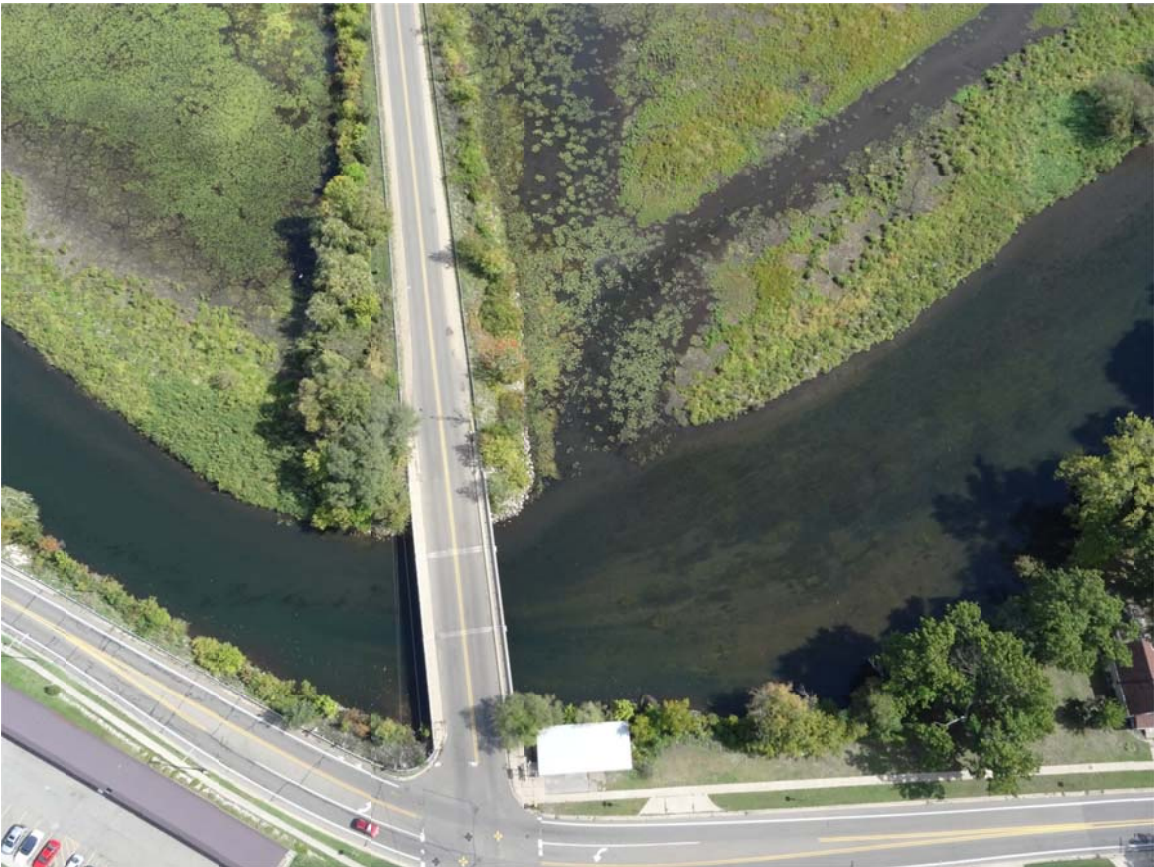
14. MP15.5 South Mill Pond no sheen observed.

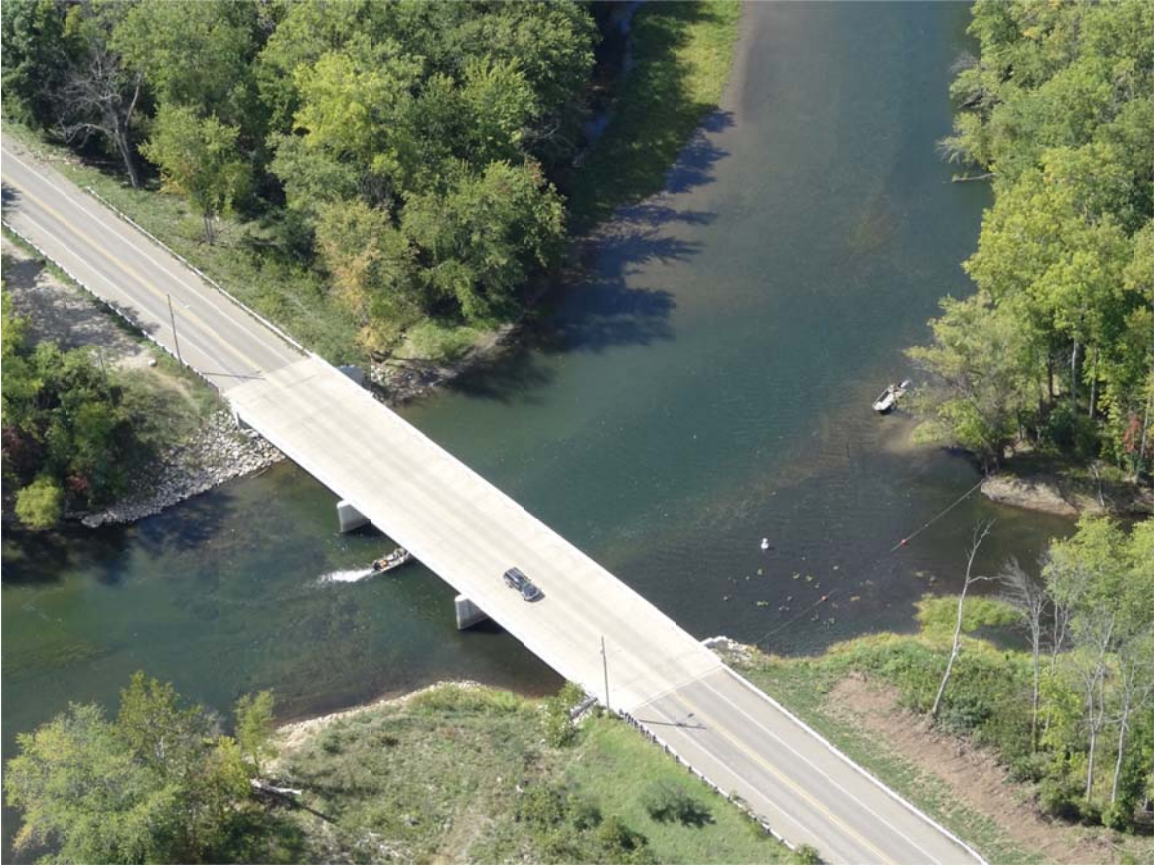
15. MP21.5 observed a bathymetry crew.

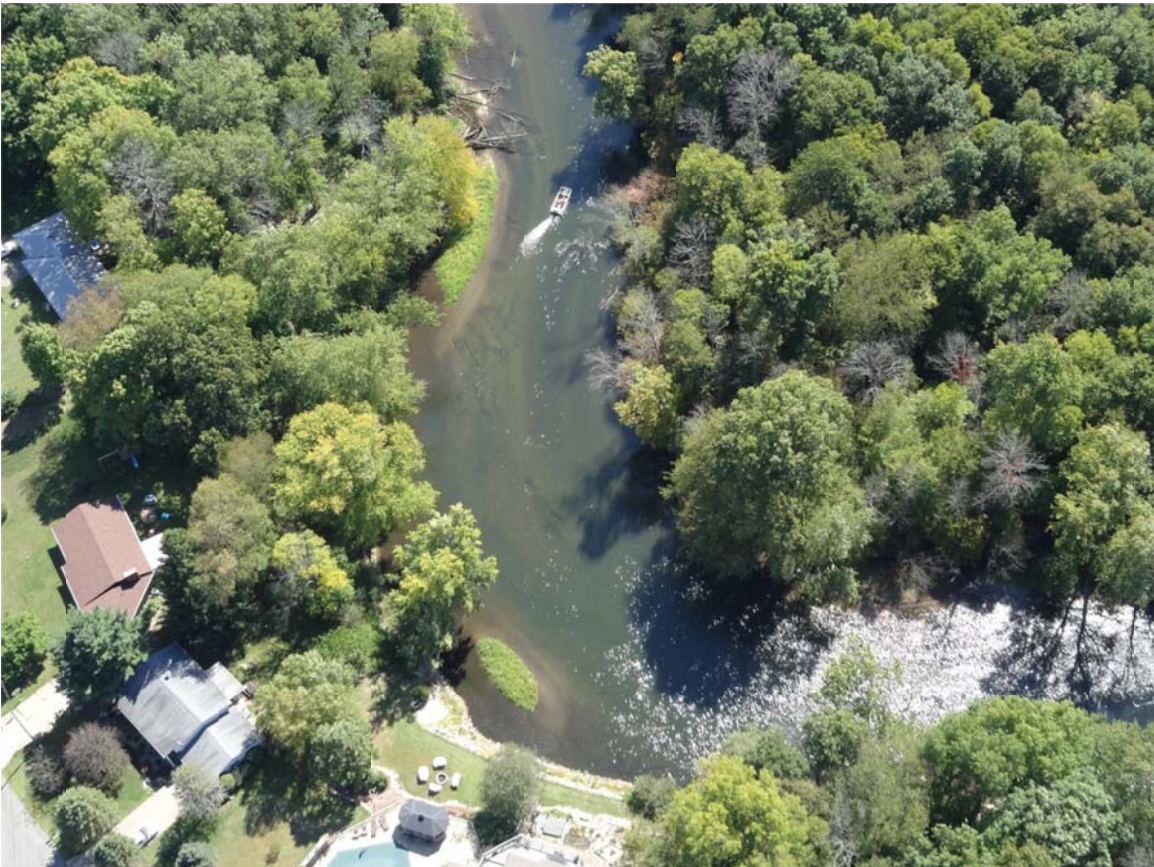
16. MP23.0 observed the situation boat.

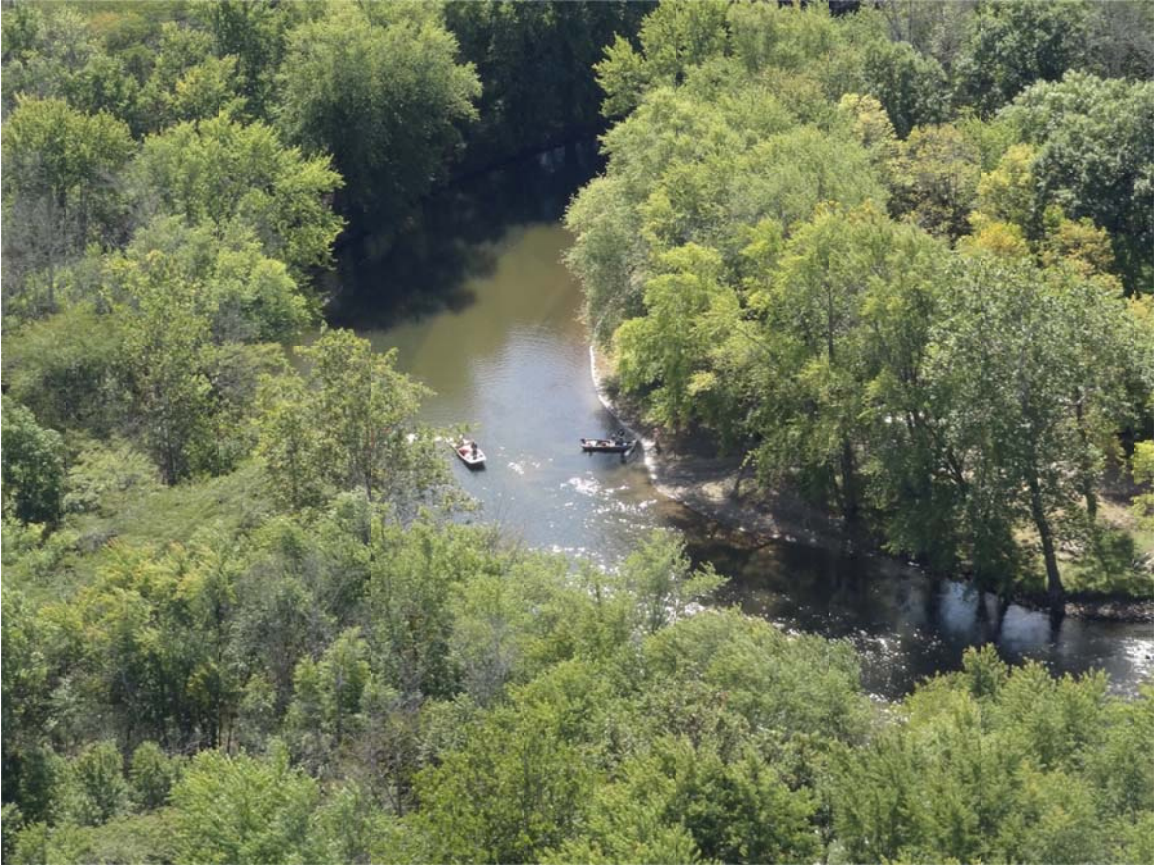
17. MP27.0 Shady Bend Campground boat launch observed the safety boat and sweep boat.

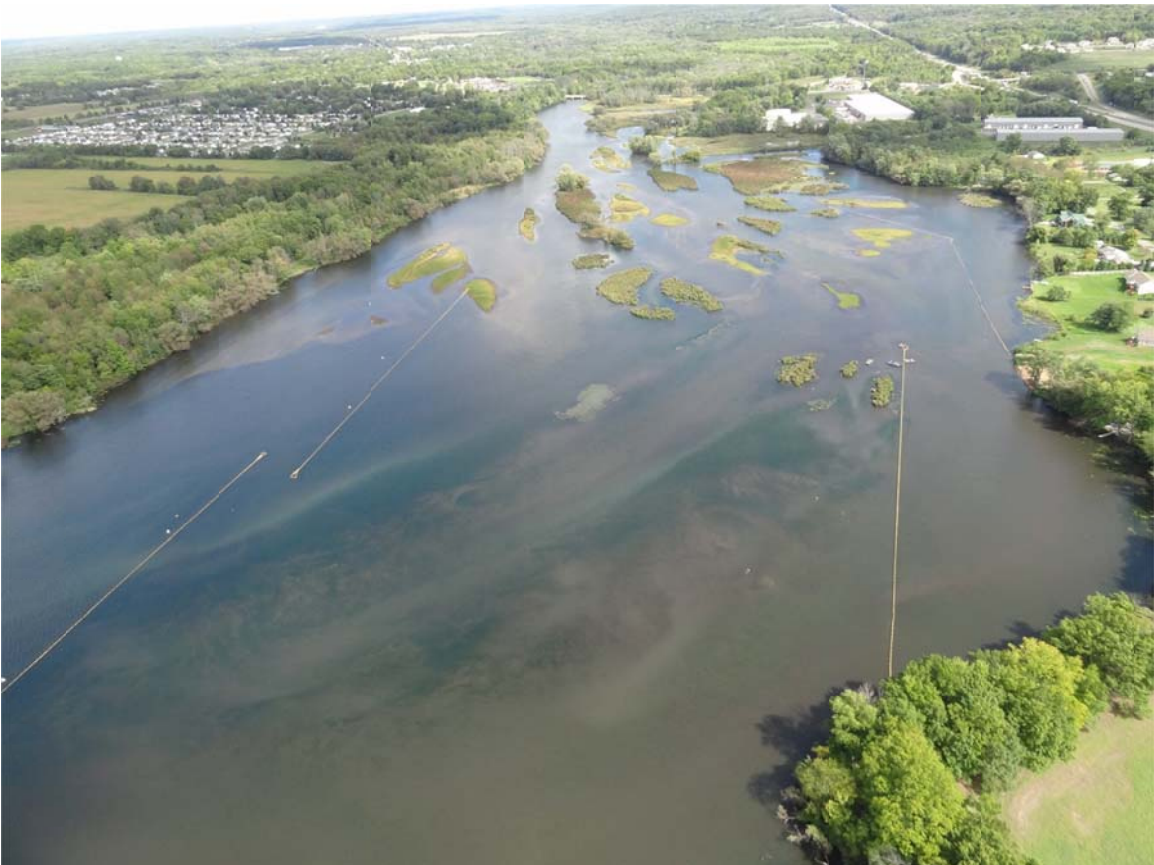
18. Morrow Lake Delta overview.

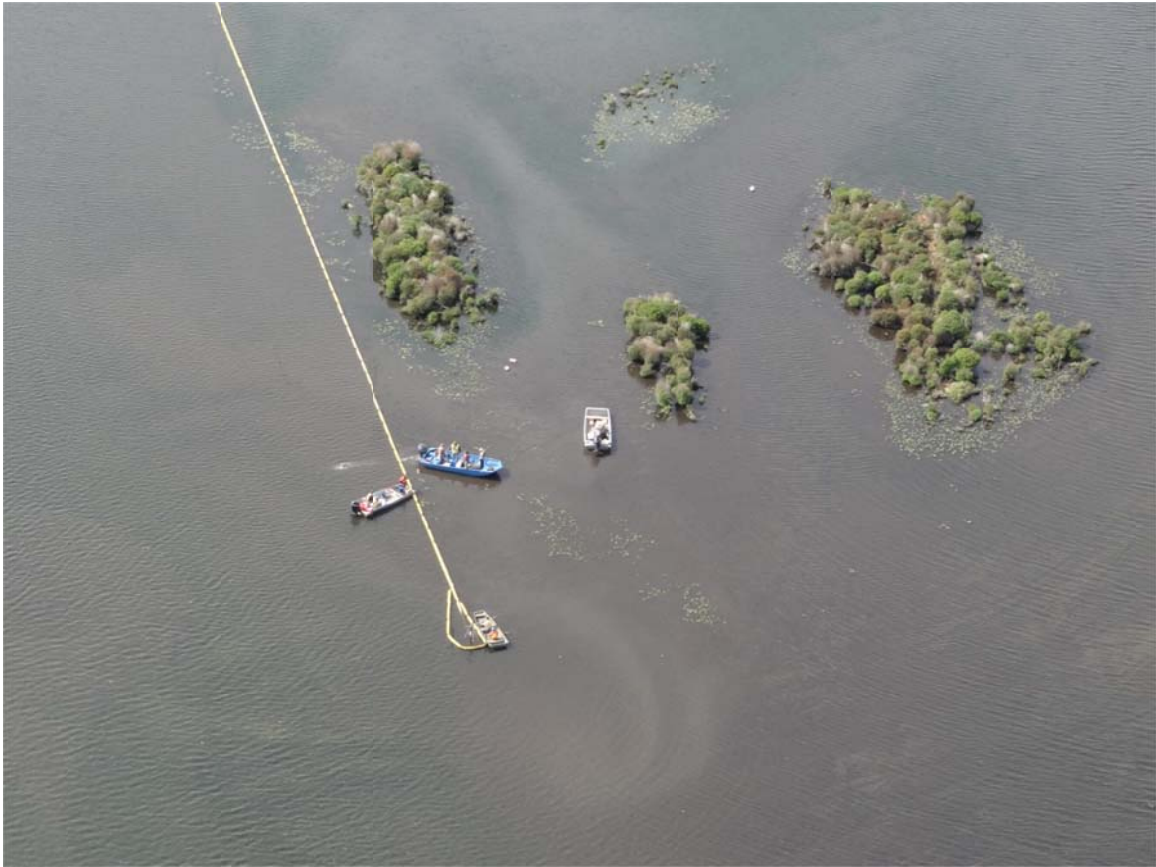
19. Morrow Lake Delta observed a bathymetry crew working along Gate B.

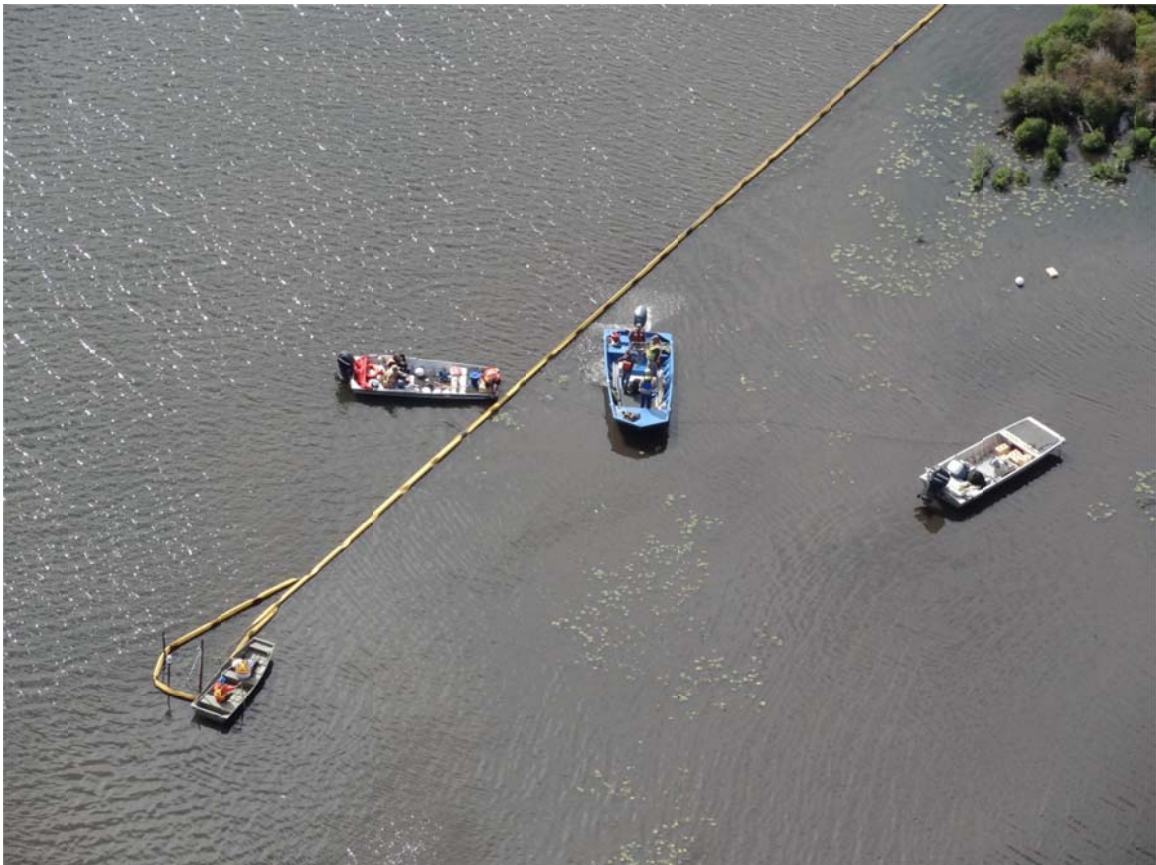
20. Morrow Lake Delta observed a bathymetry crew working along Gate B.

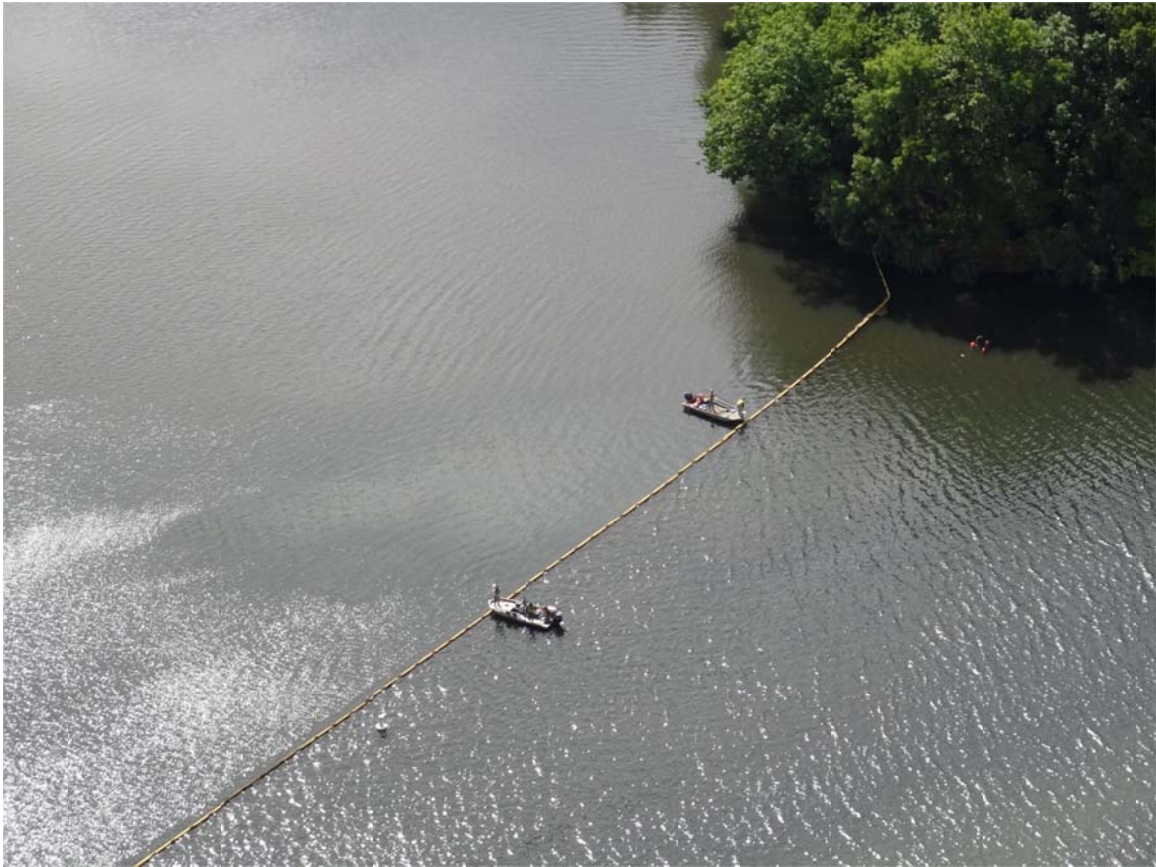
21. Morrow Lake Delta observed a bathymetry crew working along Gate C.

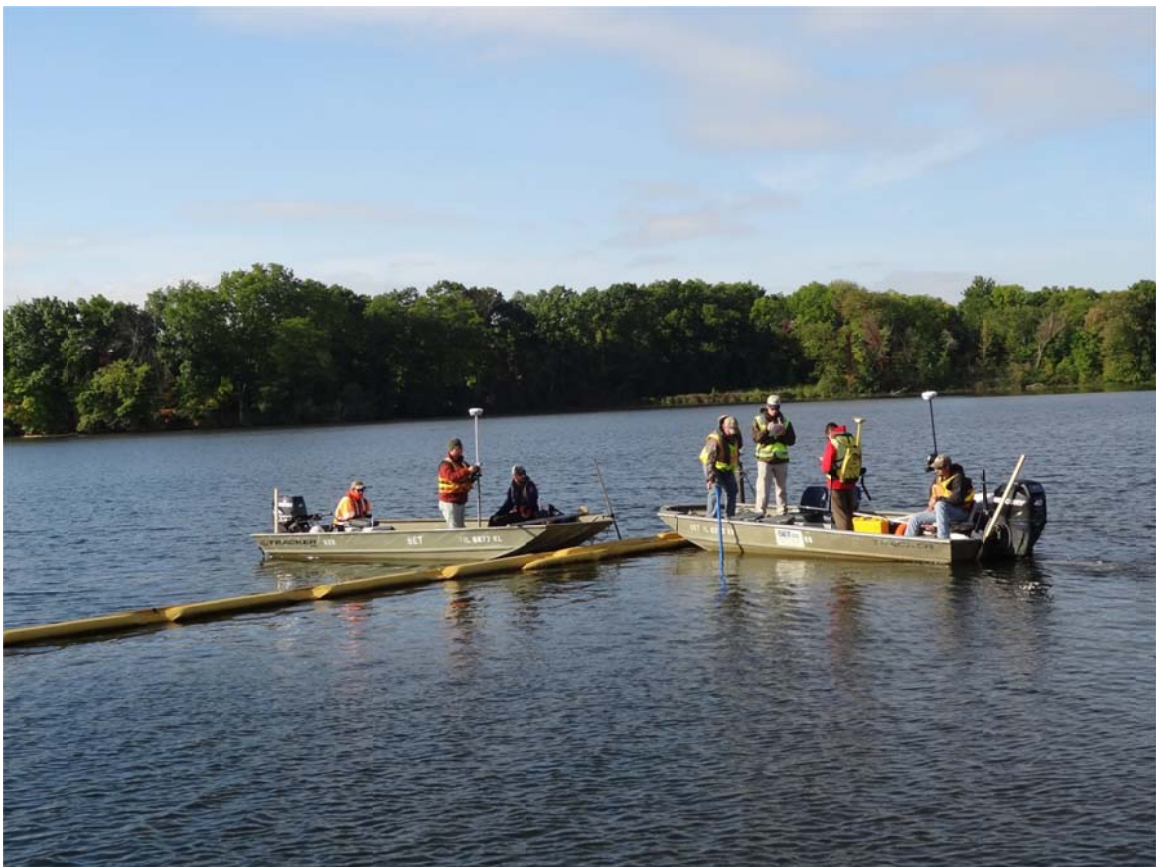
22. Morrow Lake Delta observed a bathymetry crew working along Gate C.

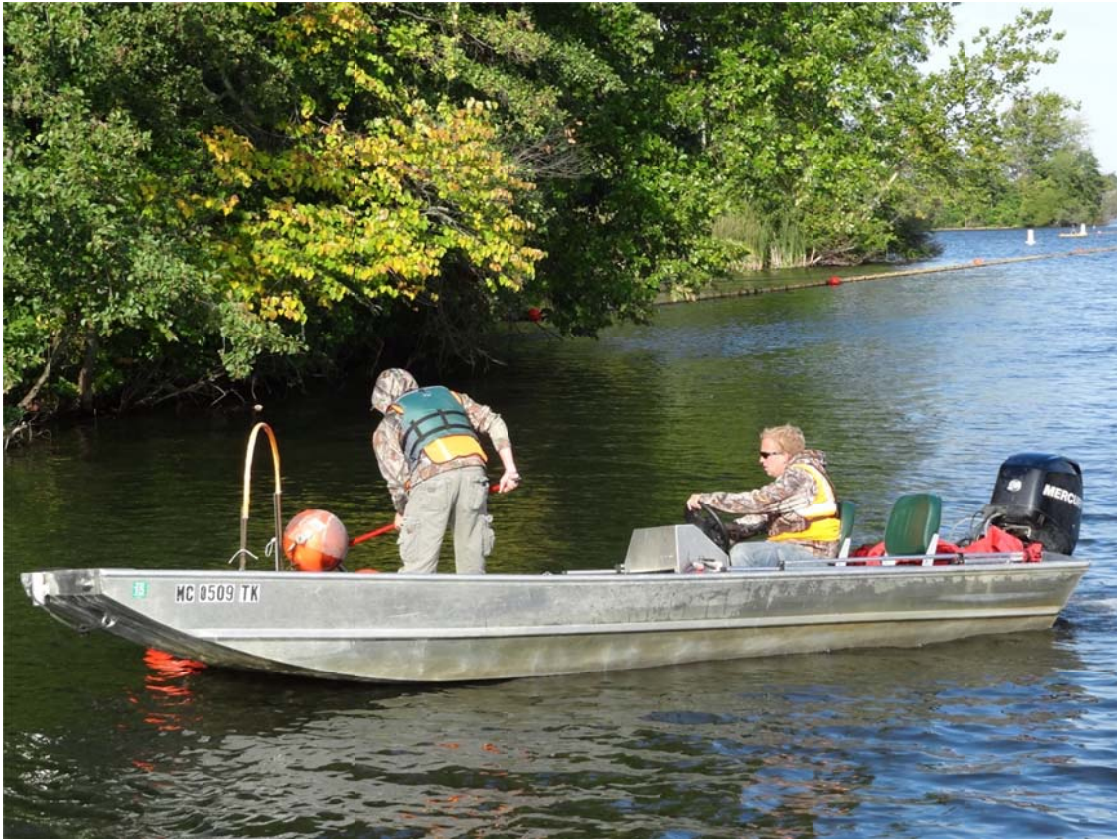
23. Morrow Lake Delta observed a Walling Tube maintenance crew.
